321 COPELAND DRIVE LAKE COPELAND HISTORIC DISTRICT

PROJECT OVERVIEW

Major Certificate of Appropriateness to demolish the existing structure and rebuild in a new style.

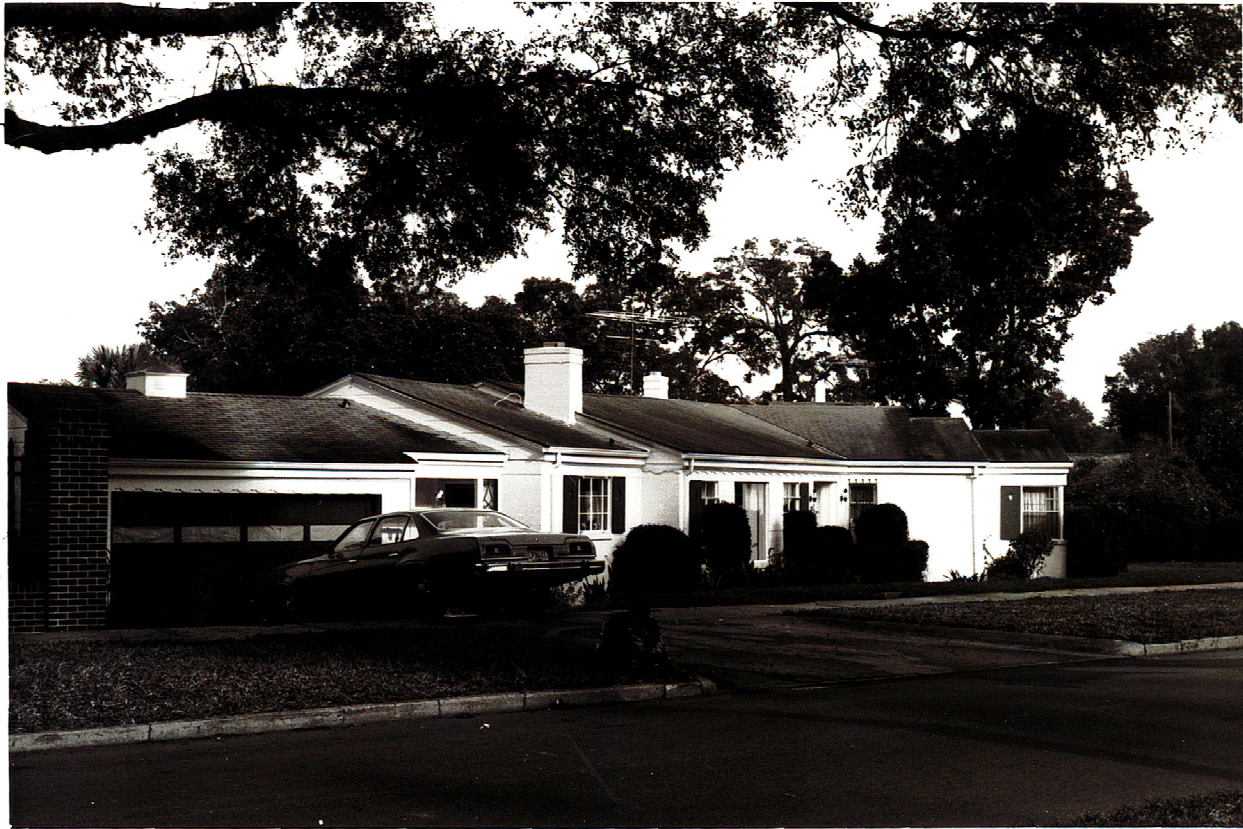
FLORIDA MASTER SITE FILE INFORMATION

The site was surveyed in 1981. The survey states that the year built is 1938 and that the area of significance is for architecture. The style is listed as "Colonial Cottage". The structure has a low pitched gable roof, casement windows, prominent brick chimney, and decorative scalloped trim. The house is noted as influenced by the Colonial Revival style made popular by Royal Barry Wills in New England. The garage was added in 1943 at a cost of \$200.

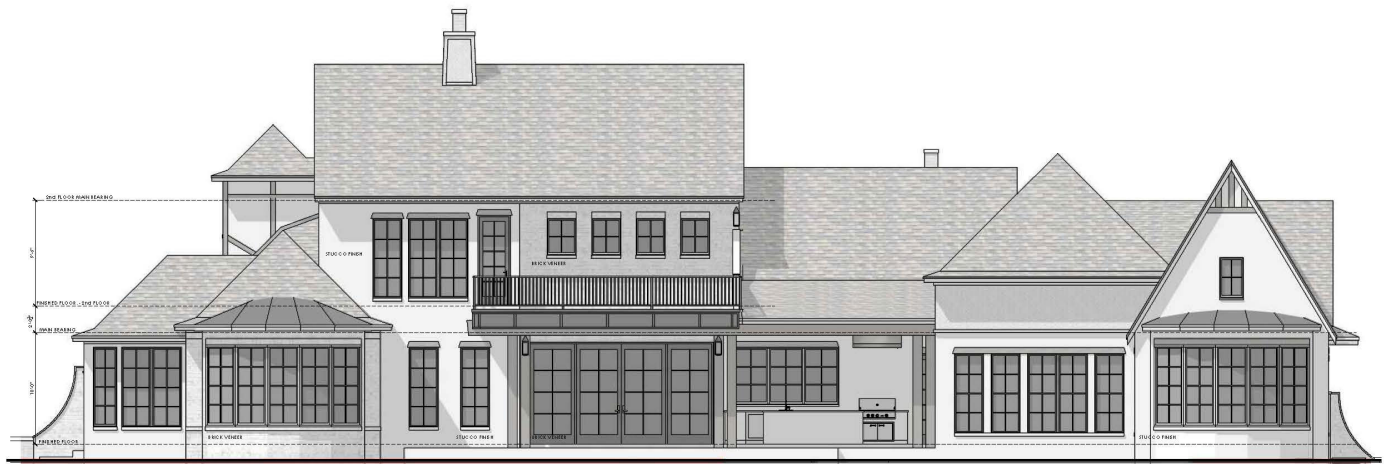
Rear Elevation: Towards Lake Copeland. Not visible.

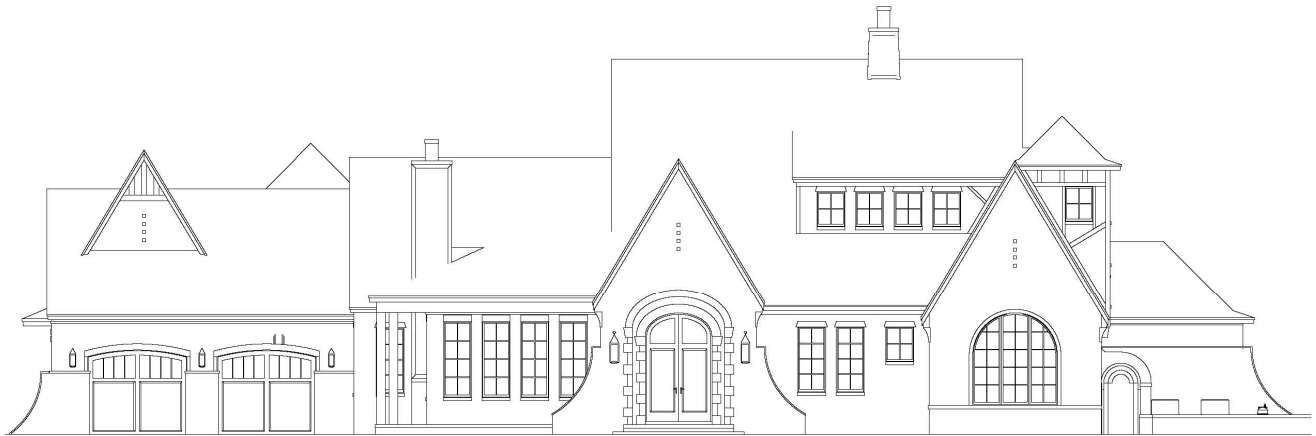
HEIGHT STUDY BY APPLICANT

The height of the proposed structure is 29'-6", just 6" below the max. allowable. The comparison house shown here is 120 Fernwood, which is more than 2 blocks away from the subject property. And was not considered by staff for comparison but is a Tudor Revival home. Staff can not confirm the scale is the same in the two images. Additionally, no corresponding lines were provided by the applicant.

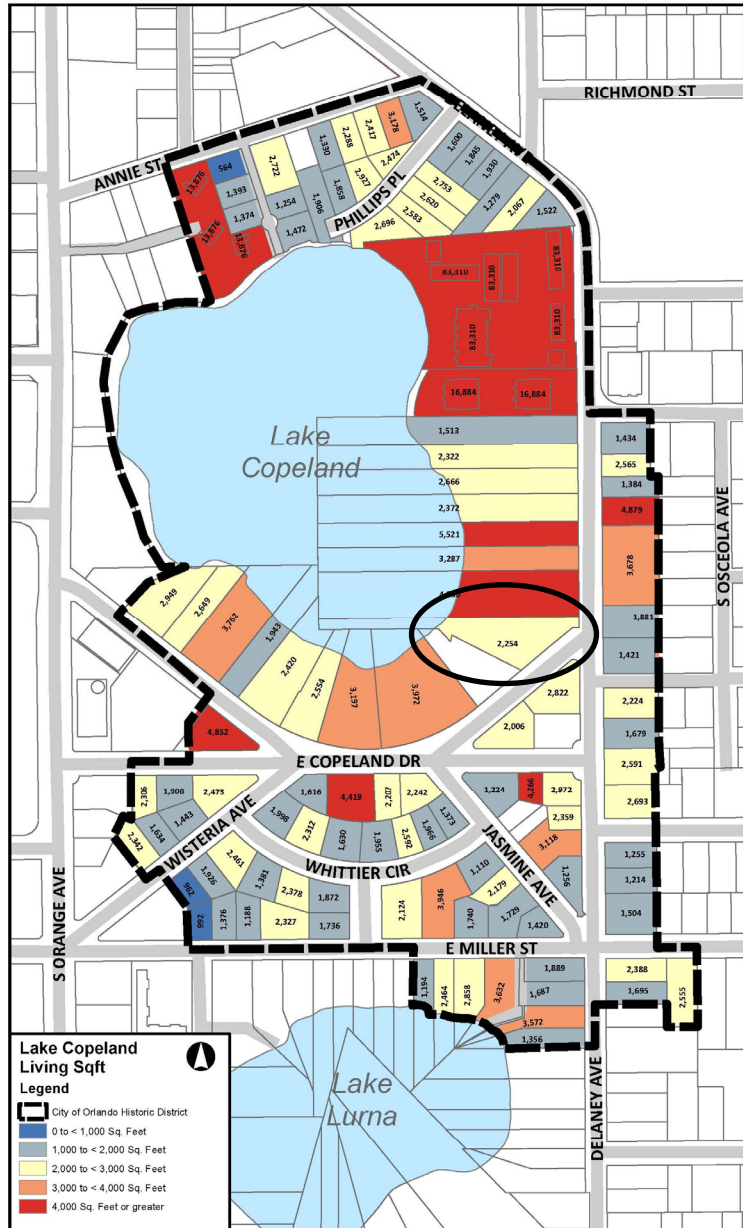
LIVING SQUARE FOOTAGE COMPARISON

- Per the Property Appraiser, the house currently has 2250 sqft. of living space.
- The new SFR will have 4,622 sq ft, more than double the current house.
- The color indicator would change to RED, which is larger than the size of the surrounding contributing properties except one.
- FAR would be .18.
- The average living sq ft of abutting properties is 1,421 sq ft to 4,250 sq ft.
- The site will have more square footage than all neighboring properties, except one.
