321 COPELAND DRIVE LAKE COPELAND HISTORIC DISTRICT

Major Certificate of Appropriateness to demolish the existing structure and rebuild in a new style.

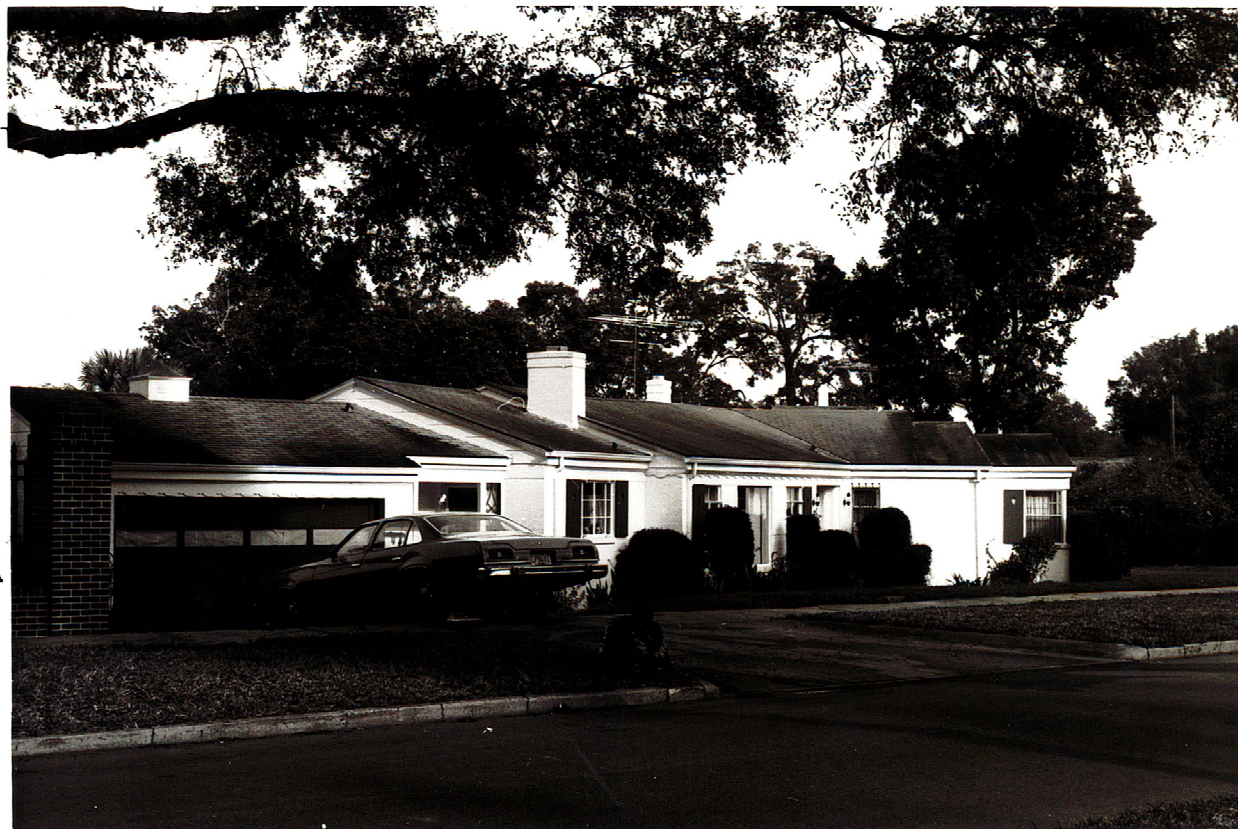
FLORIDA MASTER SITE FILE INFORMATION

The site was surveyed in 1981. The survey states that the year built is 1938 and that the area of significance is for architecture. The style is listed as "Colonial Cottage". The structure has a low pitched gable roof, casement windows, prominent brick chimney, and decorative scalloped trim. The house is noted as influenced by the Colonial Revival style made popular by Royal Barry Wills in New England. The garage was added in 1943 at a cost of \$200.

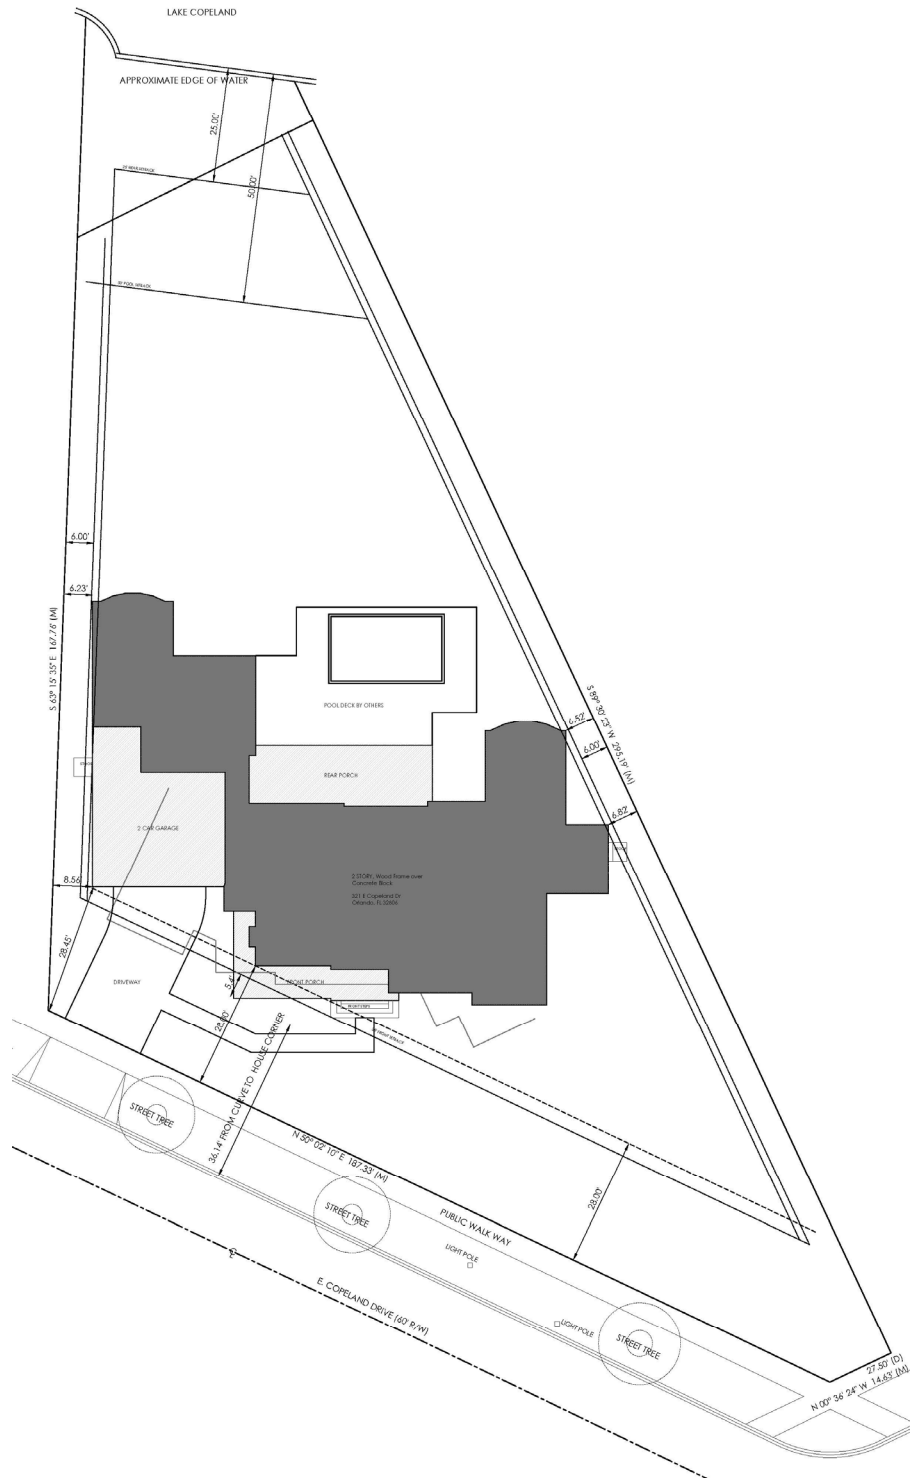
PROPOSED SITE PLAN

The proposed house is rotated on the site and is no longer parallel to Copeland which is not appropriate. The front set-back is minimal at 28 ft and does not comply with the average setback of other contributing structures in the vicinity (46 ft). Additionally, as the new structure is 2 stories with a steeply pitched roof, the mass and scale is increased when the structure is so close to the front lot line. Other 2 story contributing structures in the area have an average setback of 58 ft.

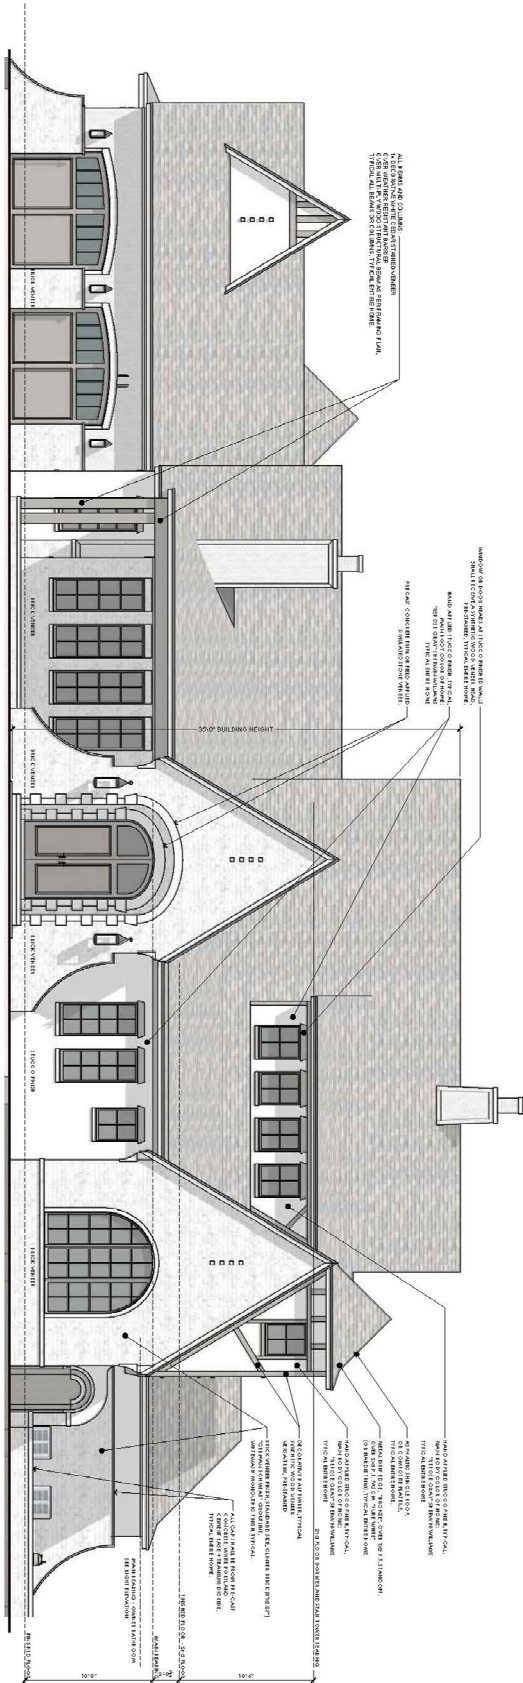
PROPOSED ELEVATIONS OF HOUSE

The proposed new structure draws from Tudor Revival influences which are not prevalent in the Lake Copeland Historic District. The height and scale of the structure is much larger than the existing building and the surrounding structures. No calculations have been provided regarding transparency. Windows are a mixture of fixed and casement as noted on the floor plans.

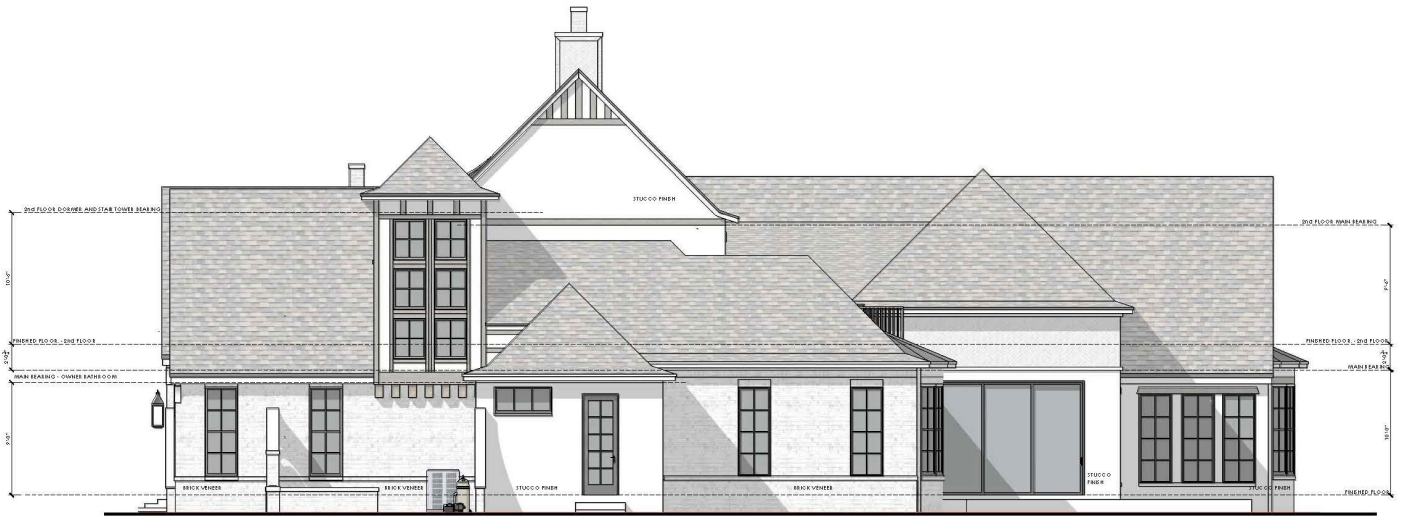
Right Side: Northeast Elevation, visible from Delaney Avenue

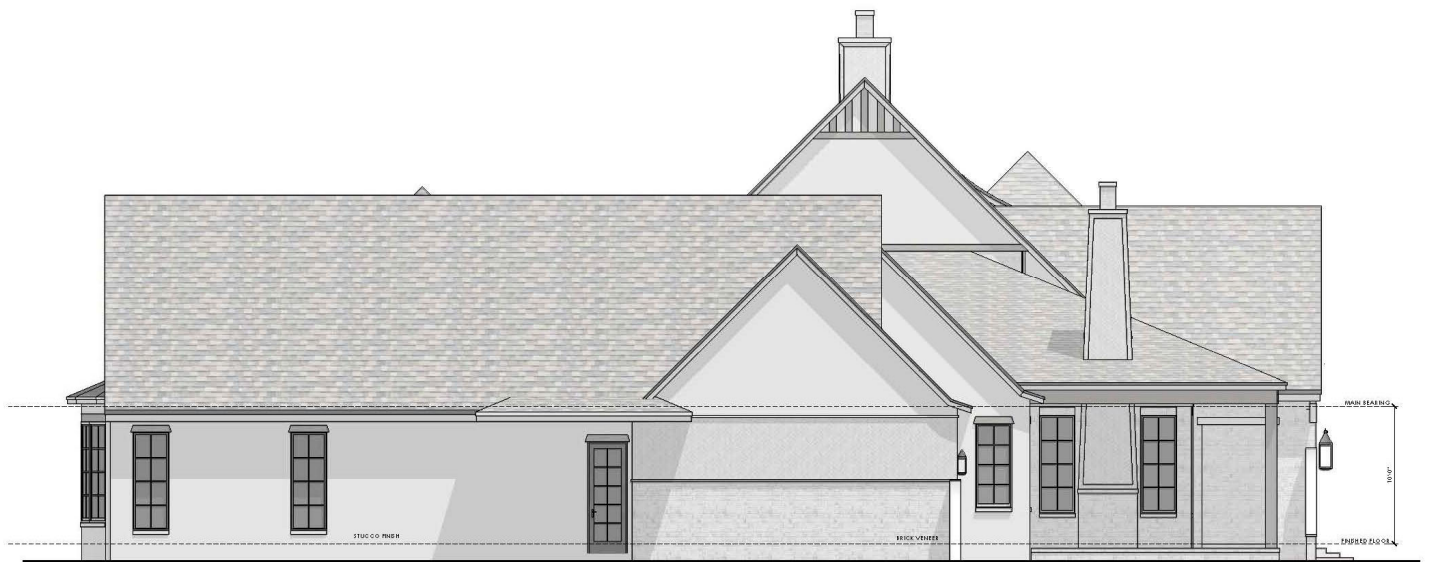
Left Side: Southwest elevation, not visible.

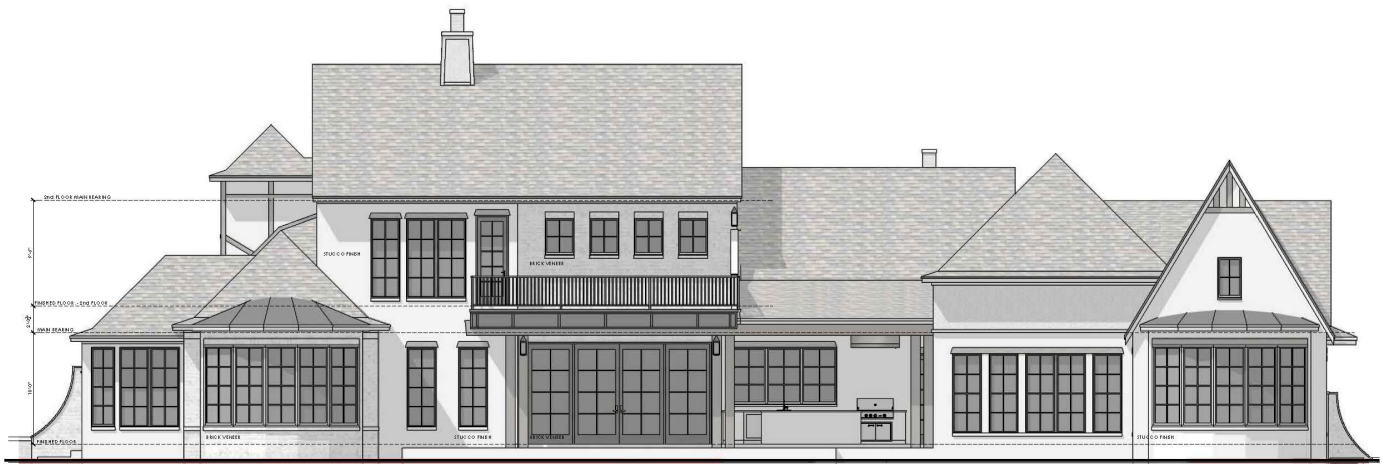
Rear Elevation: Towards Lake Copeland. Not visible.

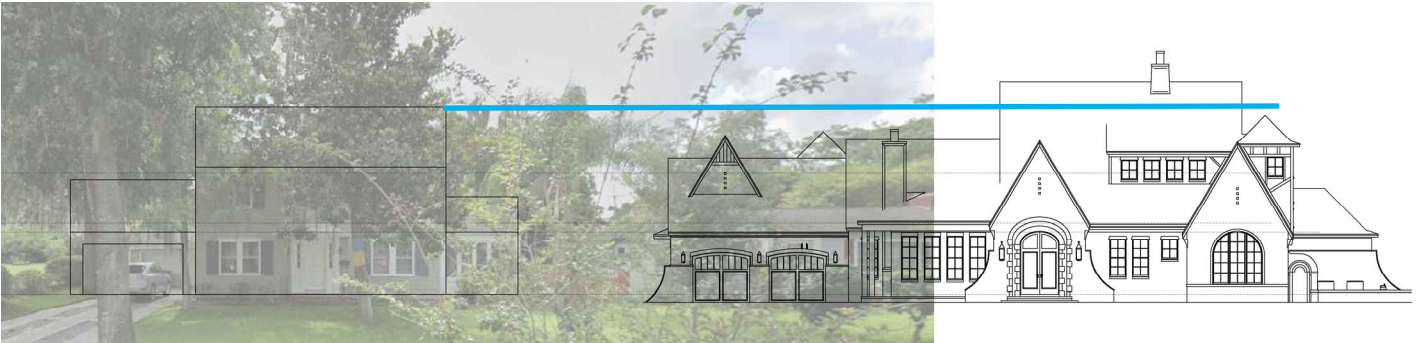
HEIGHT STUDY BY APPLICANT

The height of the proposed structure is 29'-6", just 6" below the max. allowable. No address is given for the comparison study but it appears to be 1315 Delaney. Staff cannot confirm the scale is the same in the two images. However, it should be noted that 1315 Delaney is setback 51 ft from the lot line. It's 2 story mass is therefore reduced by its placement deeper in the lot than what is proposed at the subject property.

Although corresponding lines are not provided by the applicant, the roof is lower on 1315 Delaney.

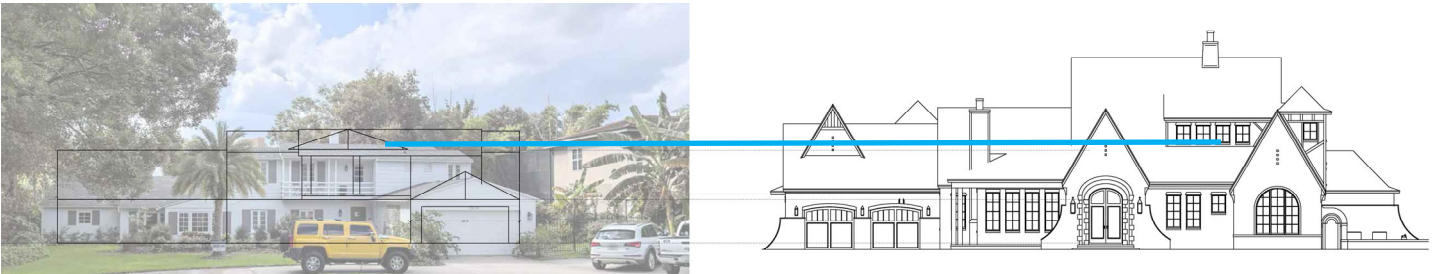
The height of the proposed structure is 29'-6", just 6" below the max. allowable. The comparison house shown here is 1304 Delany, immediately North of the subject property. Staff cannot confirm the scale is the same in the two images. It should be noted that the lines drawn over the image of 1304 Delaney are incorrect and do not accurately reflect the roof shape. 1304 Delaney does not have a forward facing gable on the second floor. It is also setback 81 ft from the lot line. Its 2 story mass is therefore reduced by its placement deeper in the lot than what is proposed at the subject property.

Since the corresponding lines are not provided accurately by the applicant, the roof is lower on 1304 Delaney. Actually, the 2 story structure at 1304 Delaney is lower than the 1 story roof proposed over the garage.

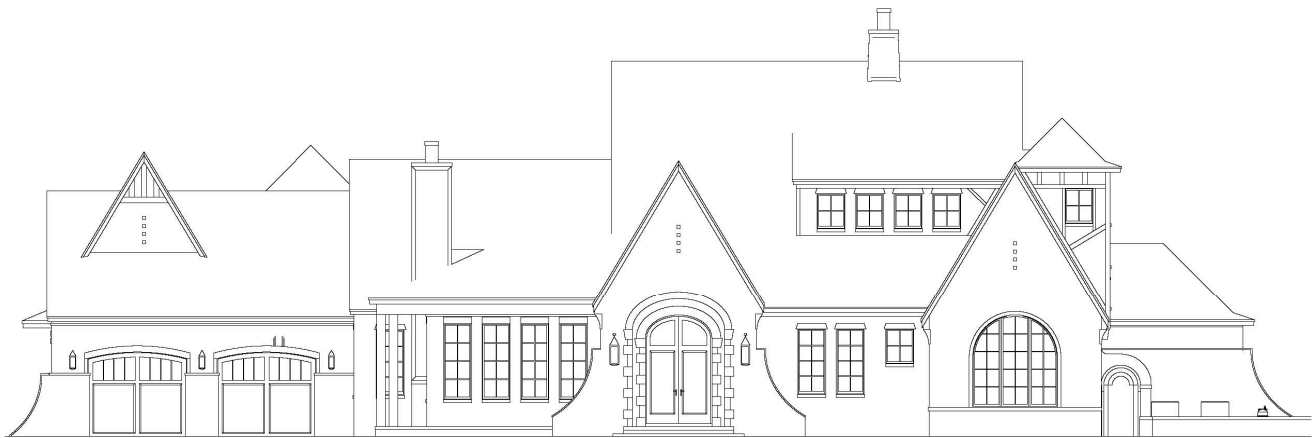
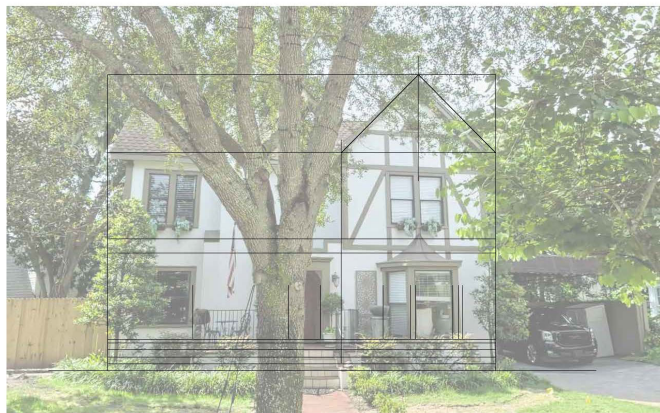
HEIGHT STUDY BY APPLICANT

The height of the proposed structure is 29'-6", just 6" below the max. allowable. The comparison house shown here is 120 Fernwood, which is more than 2 blocks away from the subject property. And was not considered by staff for comparison but is a Tudor Revival home. Staff can not confirm the scale is the same in the two images. Additionally, no corresponding lines were provided by the applicant.

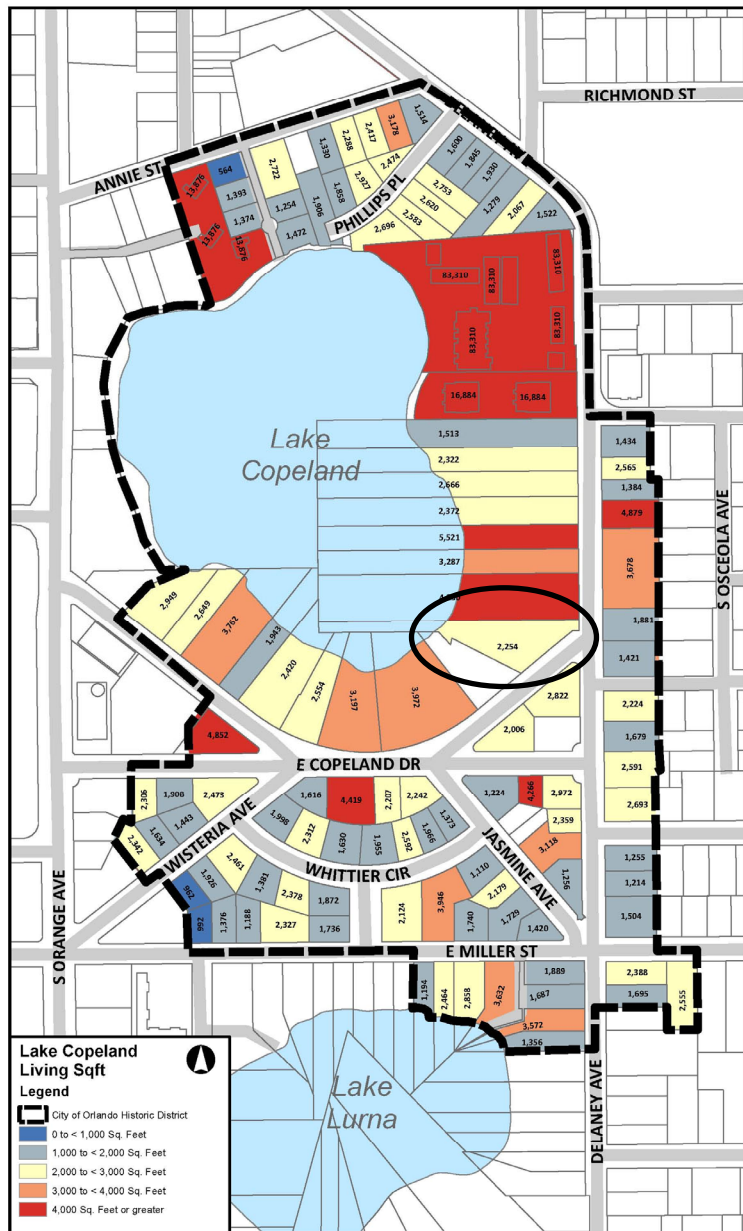
LIVING SQUARE FOOTAGE COMPARISON

- Per the Property Appraiser, the house currently has 2250 sqft. of living space.
- The new SFR will have 4,622 sq ft, more than double the current house.
- The color indicator would change to RED, which is larger than the size of the surrounding contributing properties except one.
- FAR would be .18.
- The average living sq ft of abutting properties is 1,421 sq ft to 4,250 sq ft.
- The site will have more square footage than all neighboring properties, except one.
